Case Study

Use of Power Booster resolves the following issues:

Project: **Case Study**
Use of Power Booster

file : *Case Study - 01*

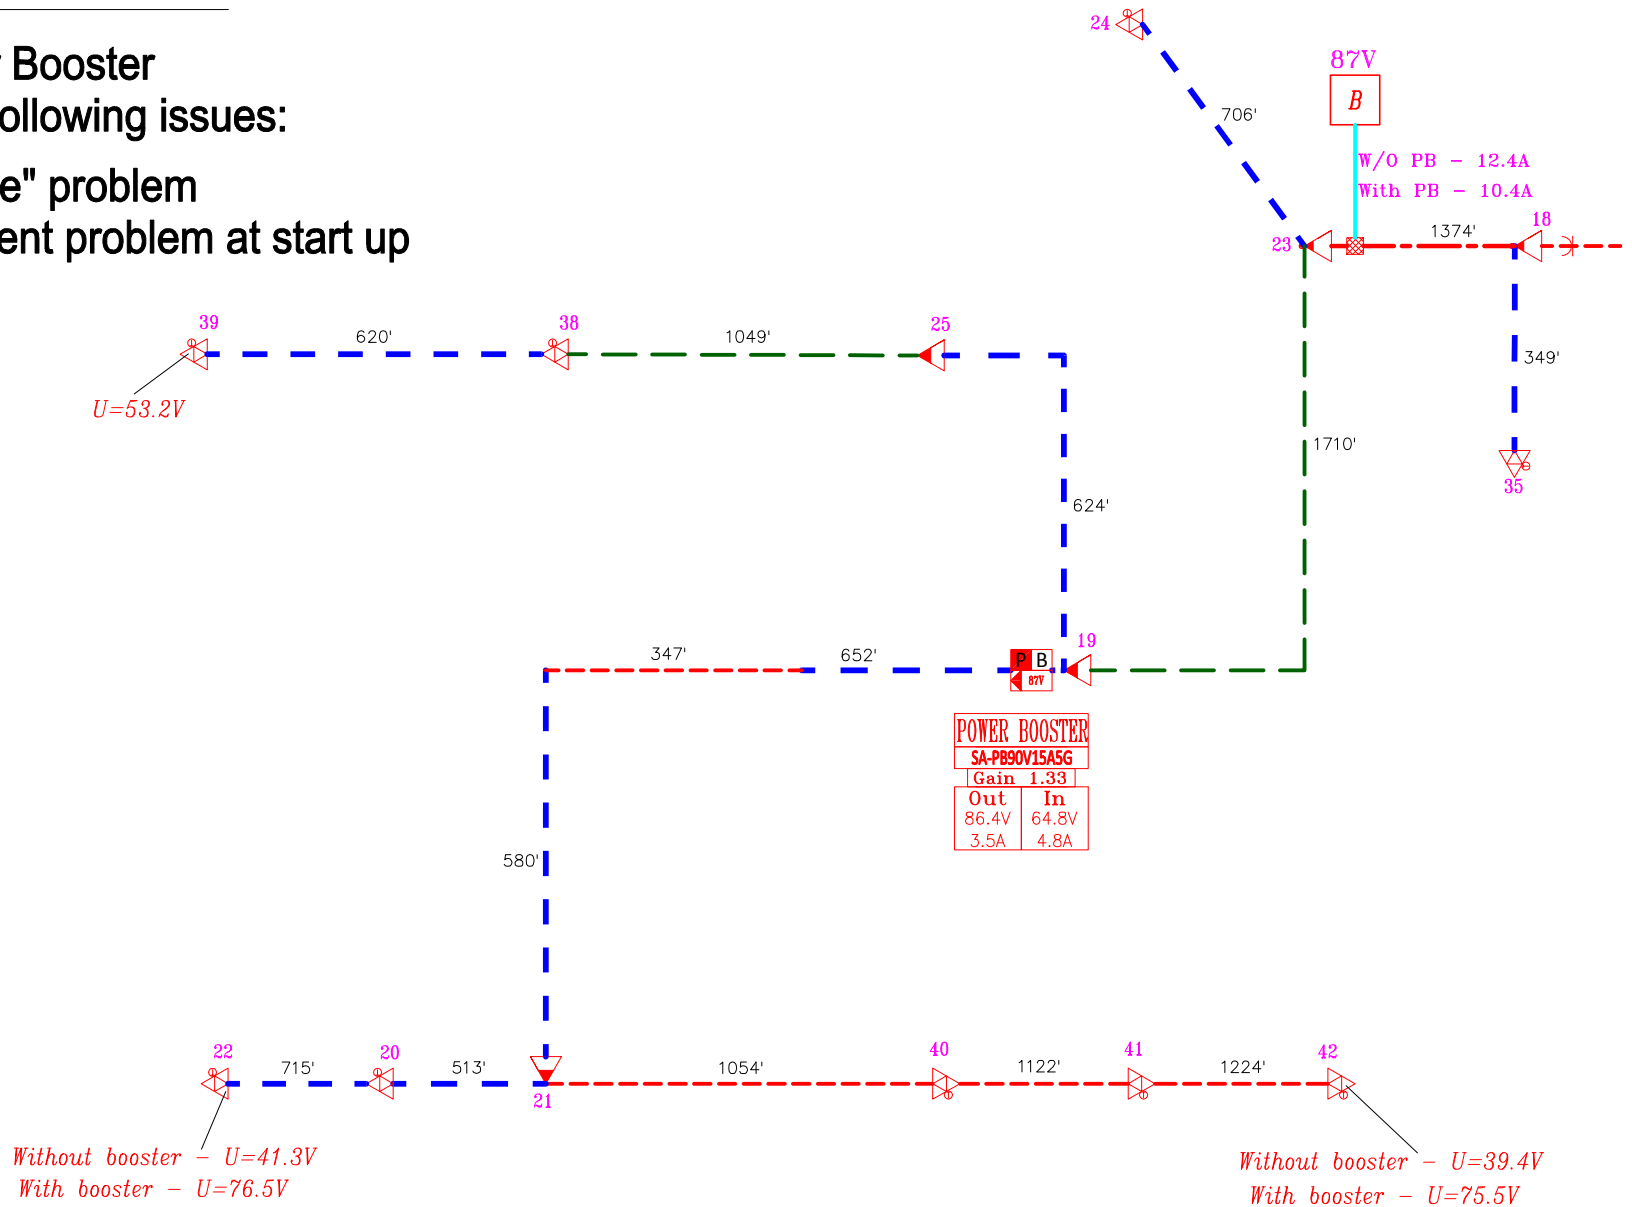
- a) "low voltage" problem
- b) inrush current problem at start up
